Contaminated Aircraft Takeoff Tests for the 1998-99 Winter

Transportation Development Centre
On behalf of
Civil Aviation
Transport Canada

October 1999

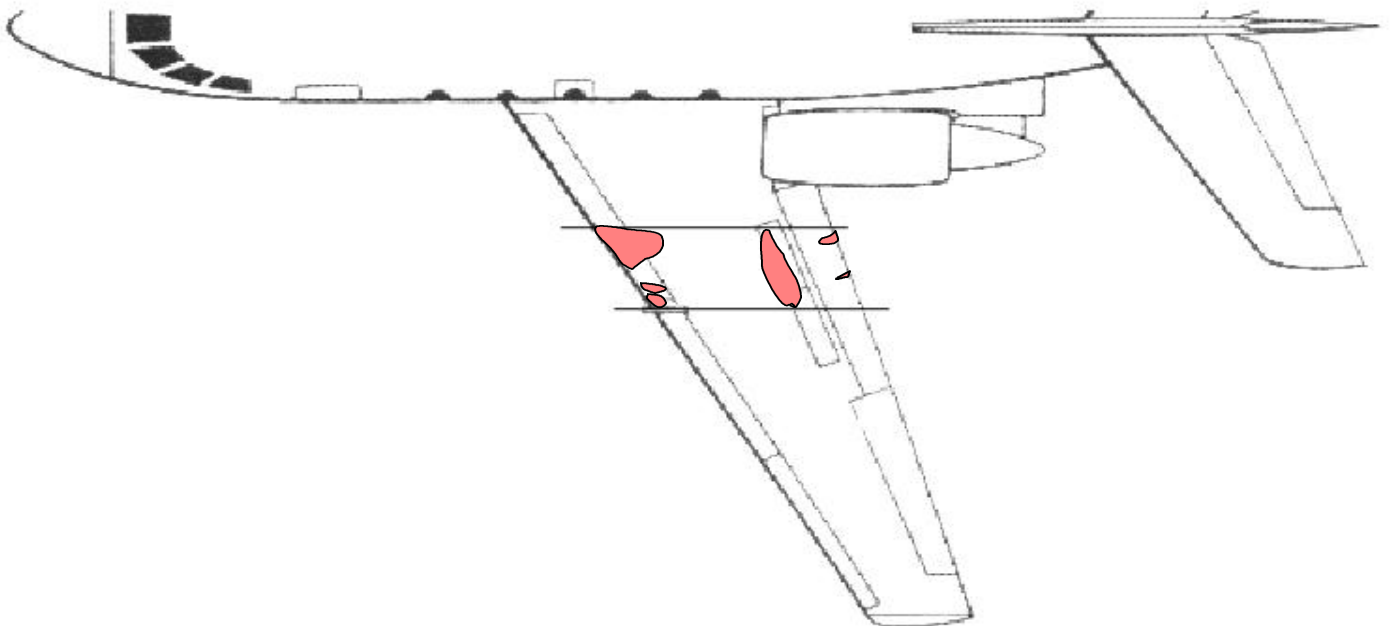
FIGURE 4.30

Run 9 - Failure Pattern After Takeoff Run

The cabin observer recorded the ice remaining on the wing surface as very similar to that recorded by the ground observer.

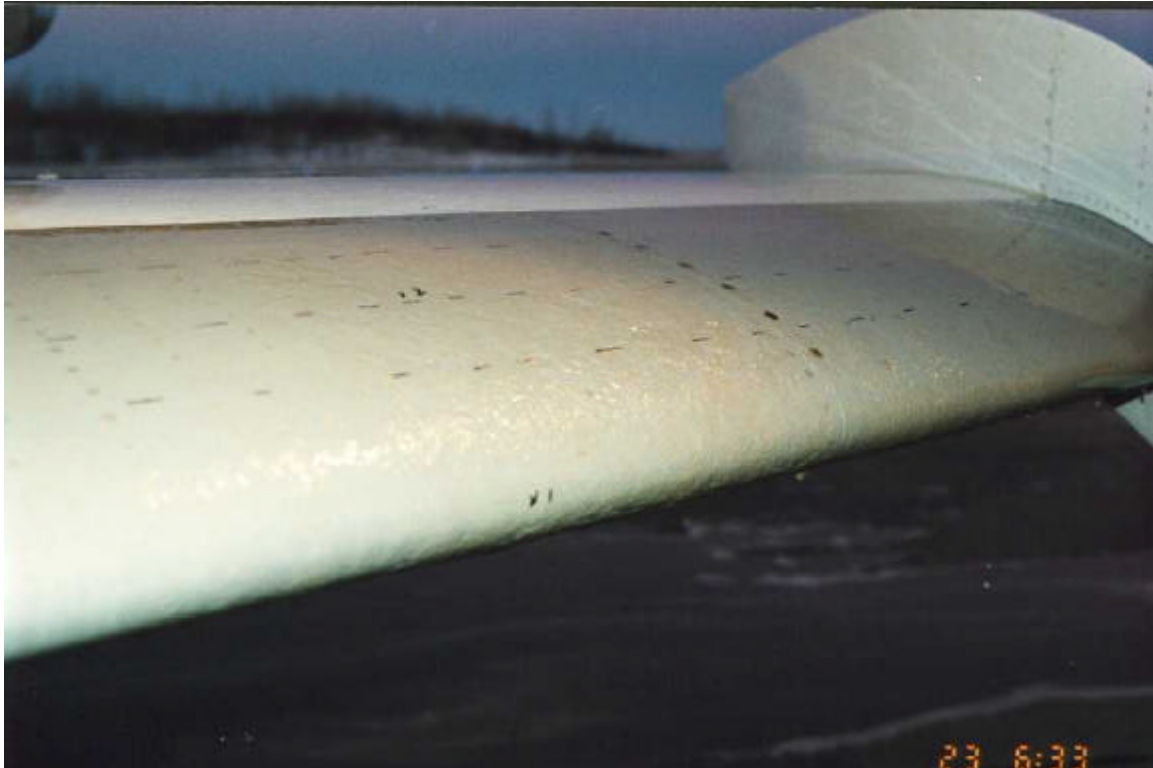
Photo 4.9
Run 5 - Appearance of Fluid Prior to Takeoff Run
Ethylene Glycol-Based Type IV Fluid at 40 Percent Contamination

Failed Fluid on Leading Edge

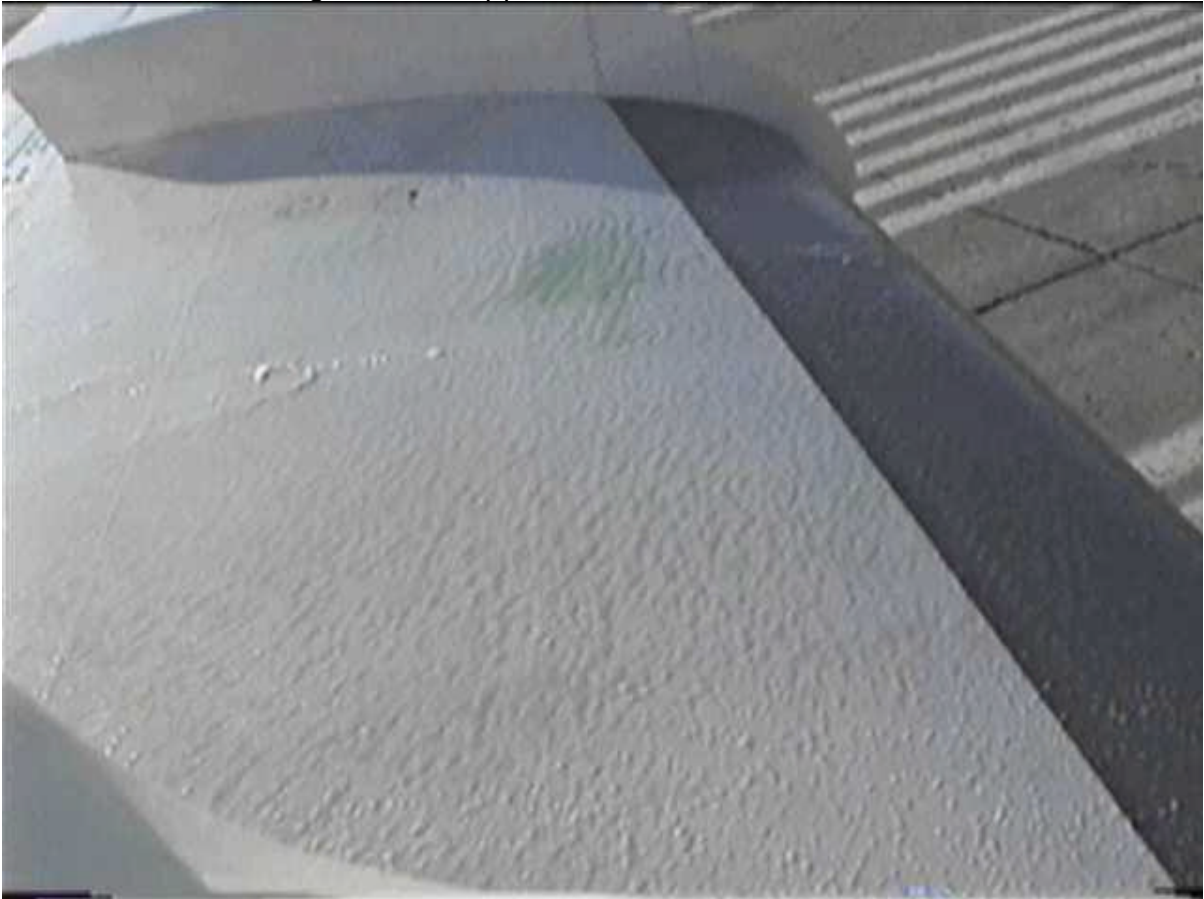
Video Image 4.1
Run 5 - Ethylene Glycol-Based Fluid, at 40 Percent Failure

Wing Surface Appearance at End of Taxi Phase

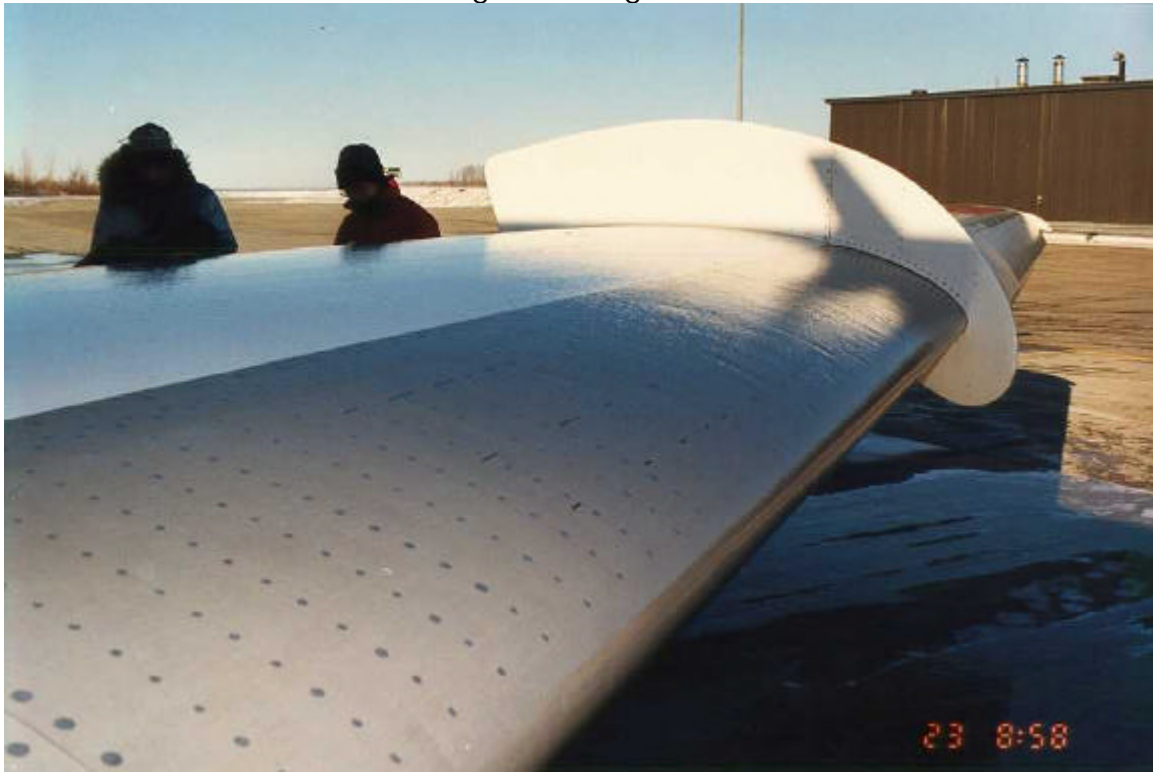
Photo 4.14
Run 7 - Appearance of Fluid Following Takeoff Run

Clear Wing Following Takeoff Run

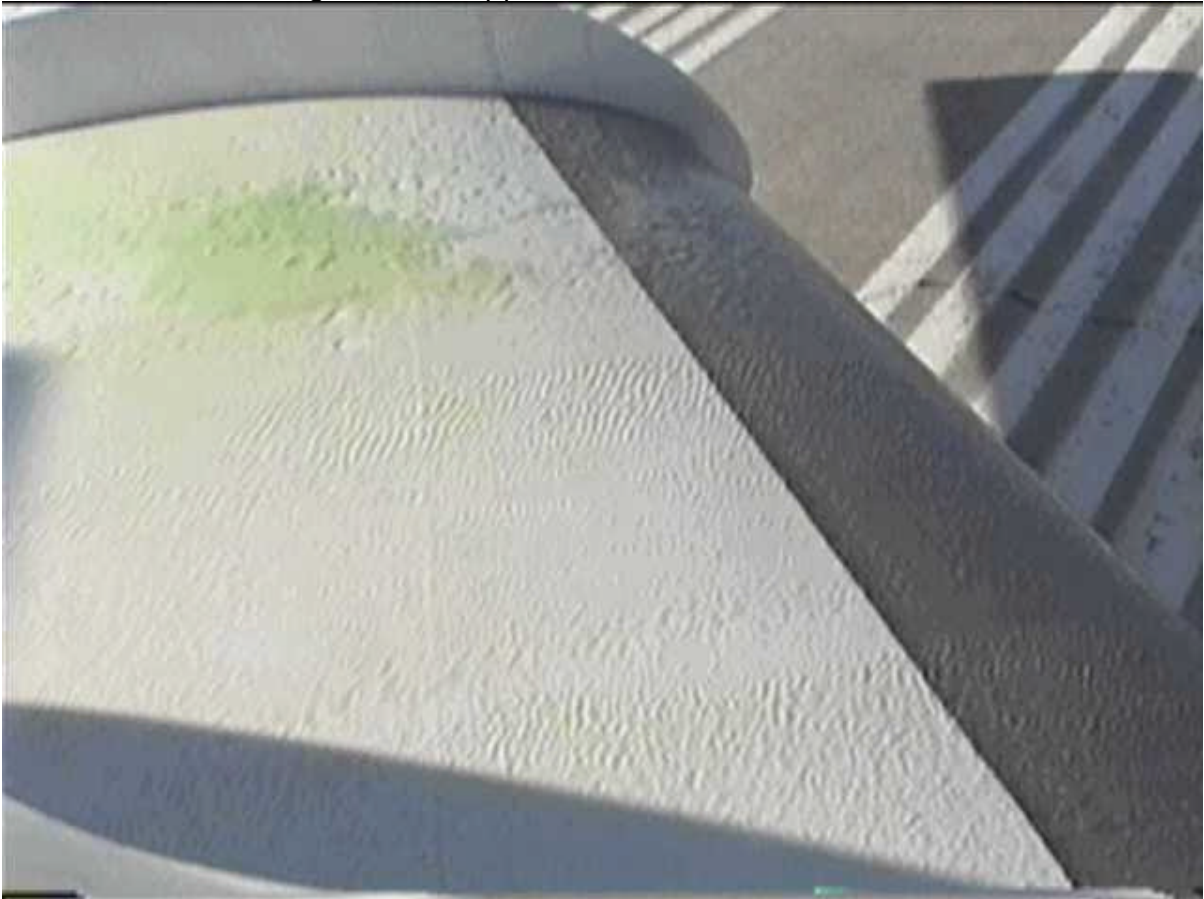
Video Image 4.3
Run 7 - Propylene Glycol-Based Fluid, at 100 Percent Failure

Wing Surface Appearance at End of Taxi Phase
